PRELIMINARY FACTUAL FINDINGS REPORT
Derailed of Union Pacific's Unit Crude Oil Train ONETU 02
Transporting Bakken Crude Oil for U.S. Oil
Mosier, Oregon

June 23, 2016

Union Pacific/U.S. Oil Mosier, Oregon Crude Derailment

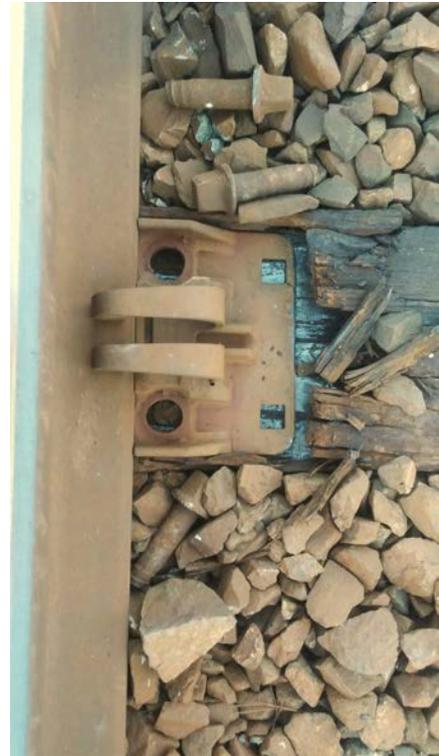
FRA's preliminary investigation determined the Union Pacific derailment was caused by broken lag bolts leading to wide track gauge.

FRA's investigation found that multiple lag bolts in this section of Union Pacific track were broken and sheared, leading to tie plates loosening from ties. The loosened tie plates allowed for the rails to be pushed outwards as trains moved across them, eventually resulting in an area of wide gauge, leading to the derailment.

Unless or until additional details come to light, FRA has made the preliminary determination that Union Pacific's failure to maintain its track and track equipment resulted in the derailment. Broken and sheared lag bolts, while difficult to detect by high-rail, are more detectable by walking inspection combined with indications of movement in the rail or track structure and/or uneven rail wear, and are critically important to resolve quickly.

Image 1:
Image of broken bolts that allowed rails to go wide, causing wide gauge.
